**Structural Pest & Home Inspection Report**  
**#ICN9080AR015 : 23040901005**

**Client(s):** XXXXX  
**Property address:** XXXXX  
XXXX  
**Washington**

**Inspection date:** Thursday, April 23, 2009

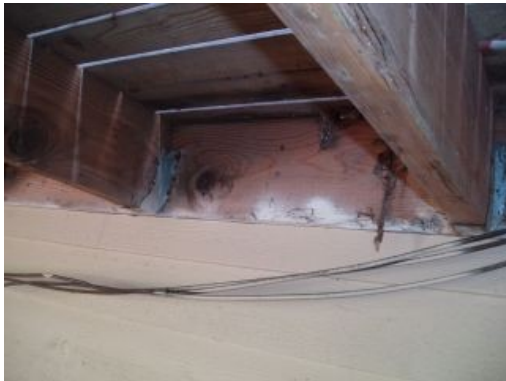
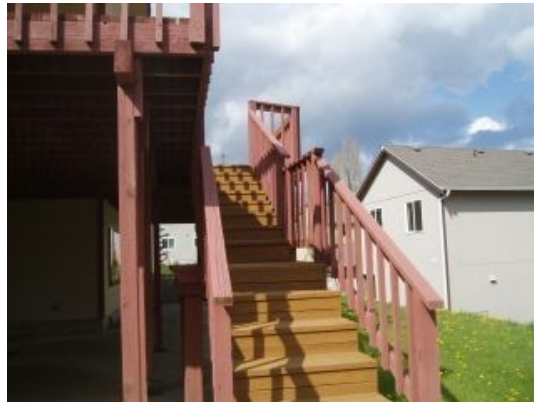
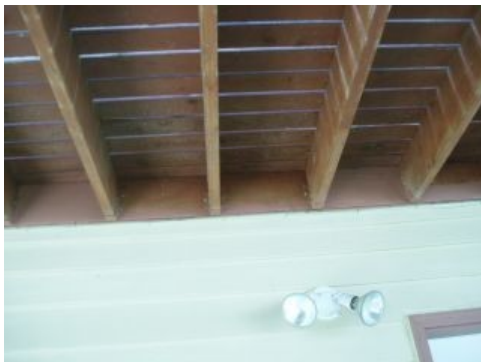
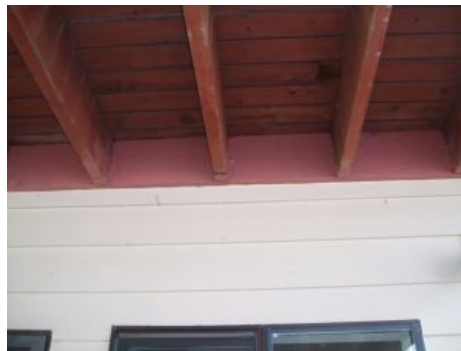
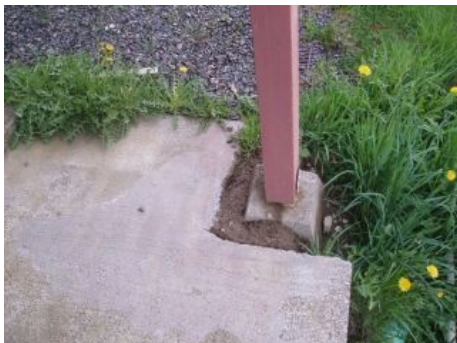
The decks need some re-painting at the front. All stair rails should have appropriate hand rails installed as per code.

The deck construction seems to be missing any deck ledger flashing and lag bolts in places.

One post pad is sitting in mud by drainage pipes and may need additional support.

Additional lateral strength and lower support is recommended to ensure deck safety.

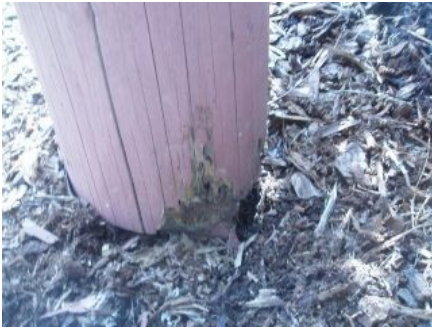
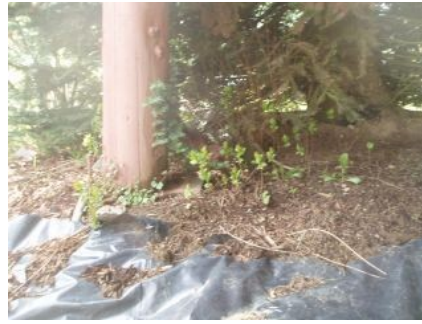
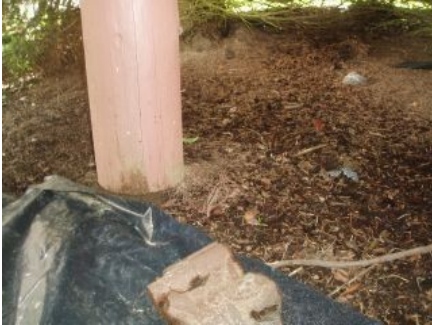
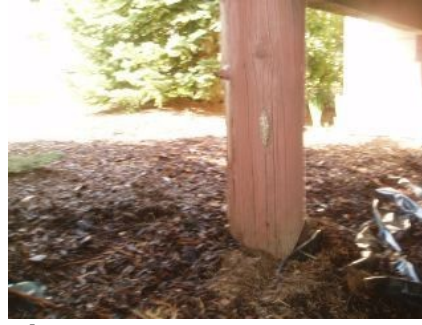
The decking materials are all aged. The Cedar support posts at the front are circling to beetle infestation and rot particularly around their bases and should be replaced appropriately. Earth to wood

contact should be removed to prevent moisture wicking and causing the above.

One major Cedar deck post at least should be treated and re-sealed. Recommend the same.

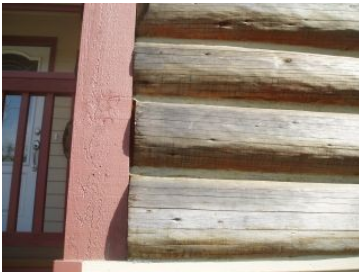
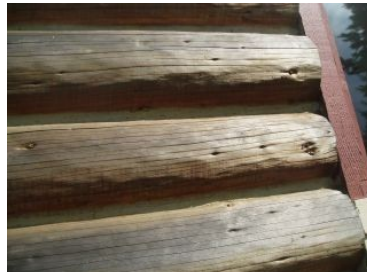
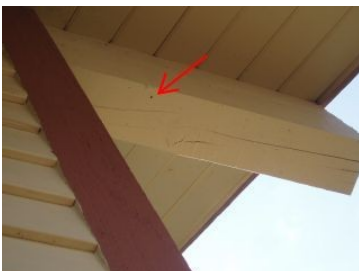
The remaining Logs in the wall structure were noted to be in need of re-sealing. Moisture is penetrating causing beetle infestation as can be seen from exit holes in several places and will continue and develop if not sufficiently sealed to prevent such occurrences. The beetles lava feeds of the internal cellulose product of the timber and therefore will cause some damage. Currently the situation is very minor.

Beetle holes could be seen on other exposed older timbers also though most have been recently painted. Exit holes are best filled. Some gaps around the logs and the chinking should be sealed also.

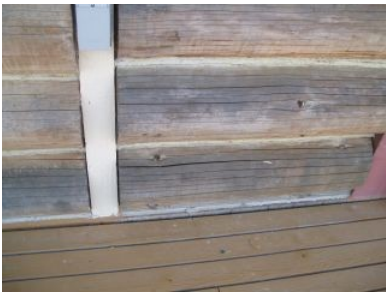
**Photo 44**

Some exposed edges where the house and deck meet are in need of weather proofing. Recommend the same.

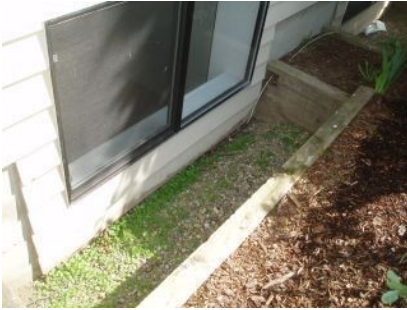
**Photo 1**

Some past earth to wood contact seems present on siding in the front basement window bays.

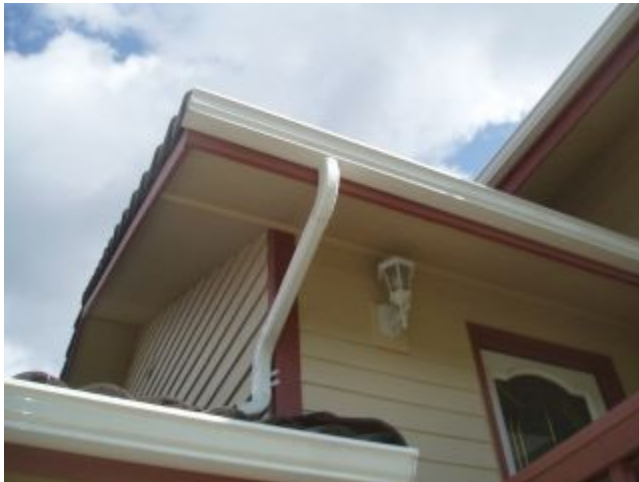
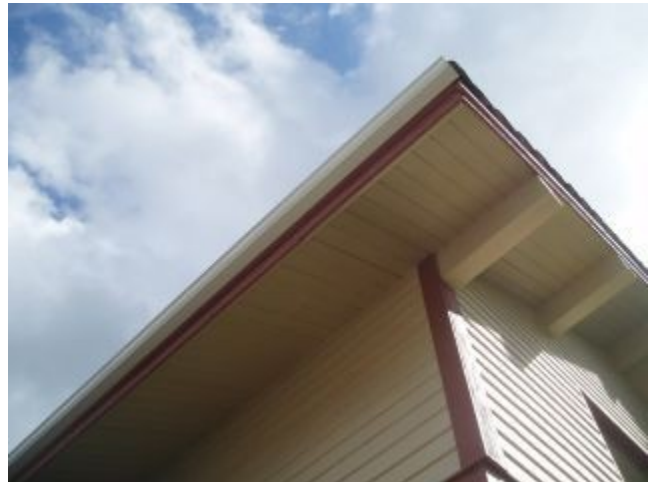
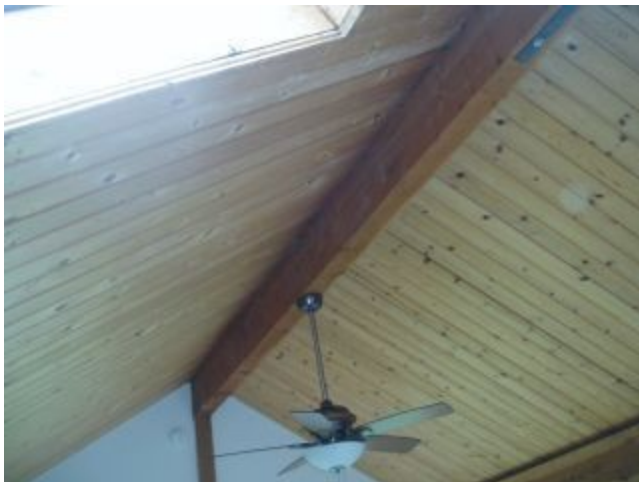
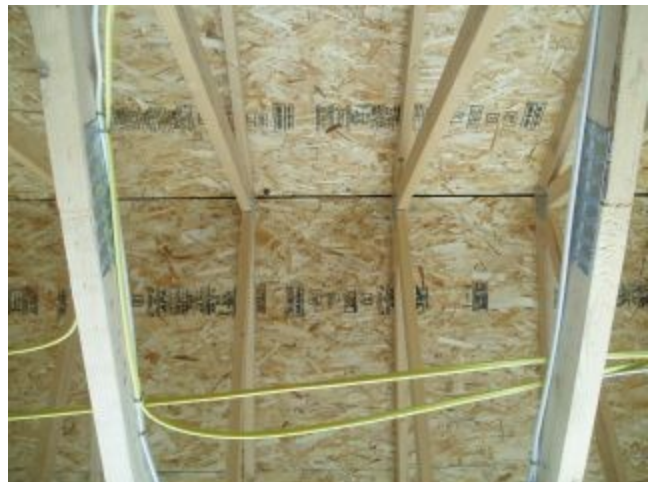
The roof is new and any warranty provided by the installer should be sought.

The main living space area is enclosed with out any ventilation and if composite sheathing is in place some future condensation issues may be an issue. Advise should be sought as to what previous material was used on the roof.

Skip sheathing can be seen in the laundry/bathroom area and full soffit vents are installed for the garage.

Some mold spotting was noted in the garage roof sheathing. This we think may have occurred during the building process but should be monitored in case not with any necessary remedy if needed.

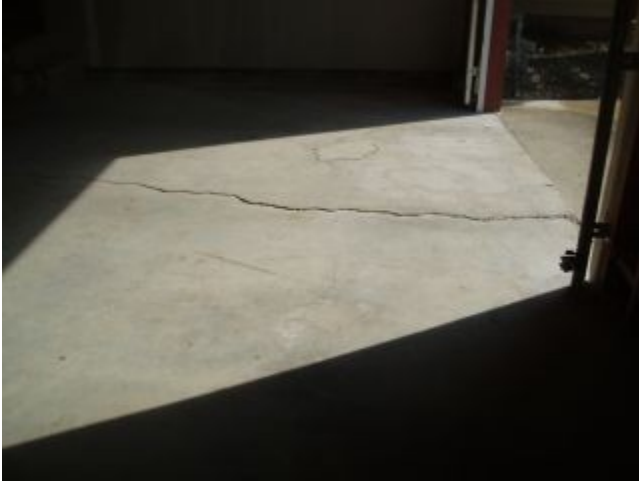
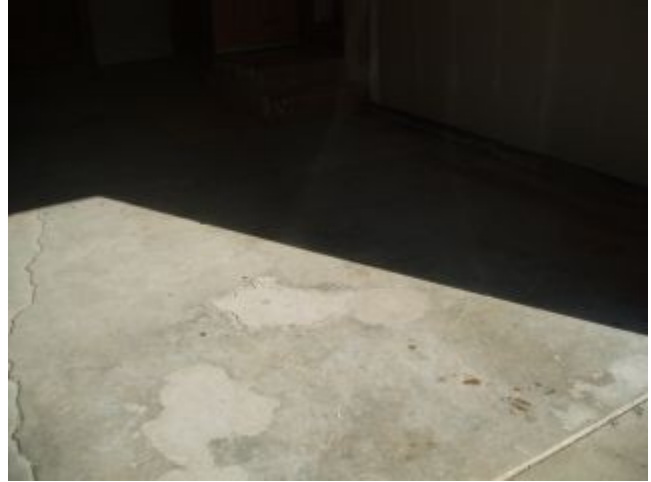
The slab has moved and cracked and is quite noticeable. Further monitoring is advised.

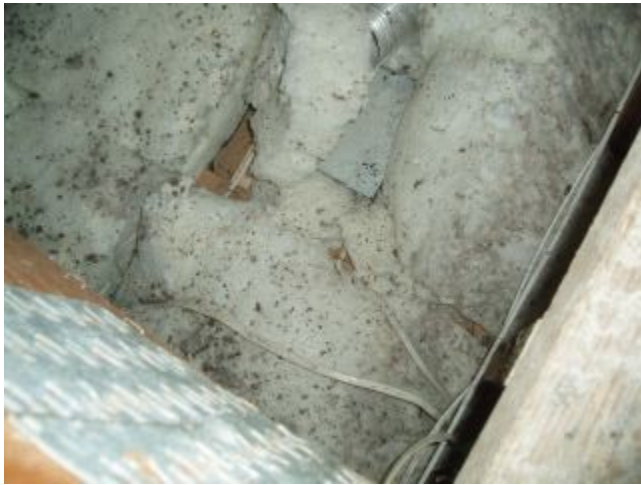
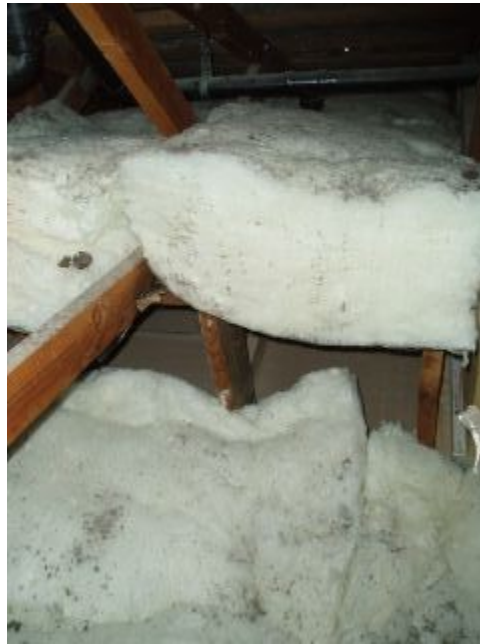
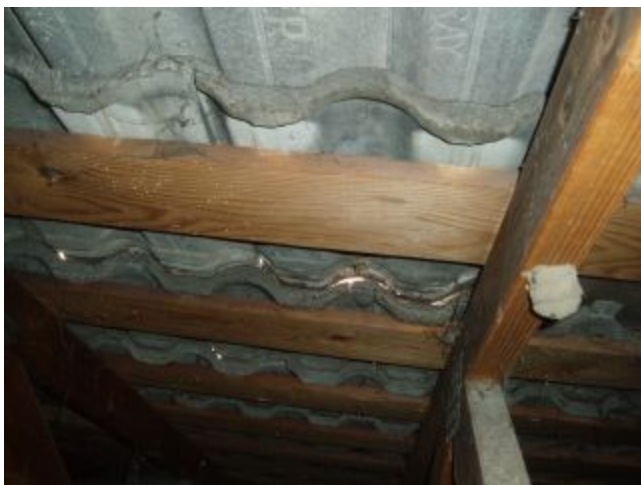
The bathroom exhaust fan duct is not connected and needs to be.

The insulation over the laundry ceiling is not sitting on the ceiling and should be. Spotting on the insulation may be from water droplets and some monitoring is recommended with any necessary remedy.

Some gaps in the roofing ties were noted and some further advise from the installer and or repair may be necessary.

Recommend appropriate repairs as required.

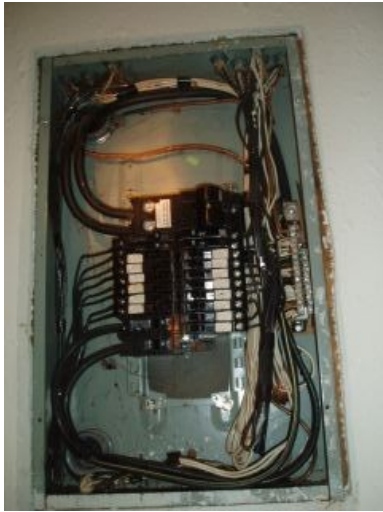
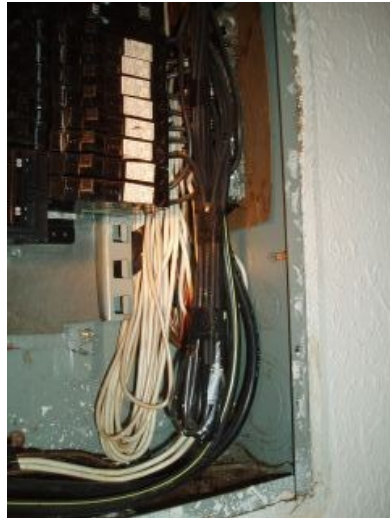
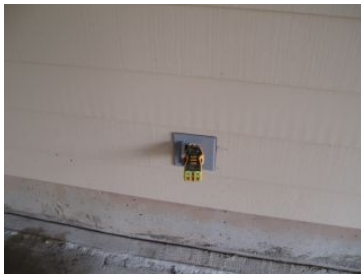
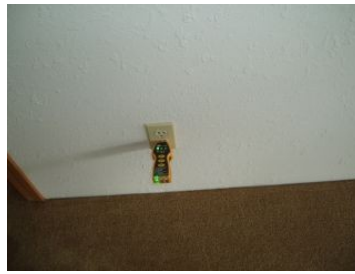
The main panel was checked and it was noted that over long cables were used in the installation and have been bundles inside. Normally this is not acceptable and may want to be addressed.

Exterior outlets and any wet area units should have GFI's installed. Recommend the same.

One outlet was found to have a wiring defect in the basement by the stairs.

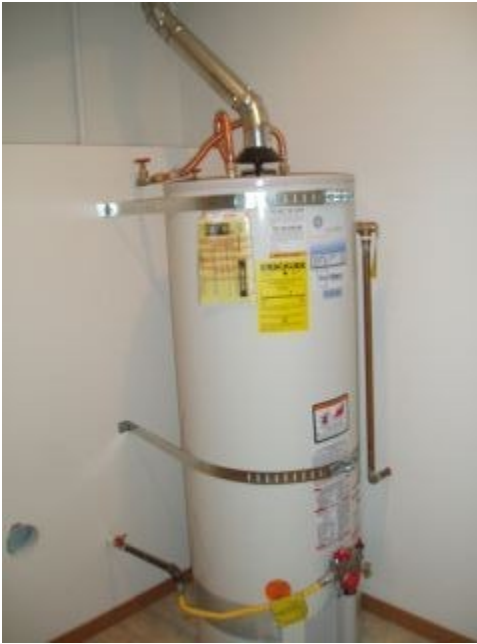
**Photo 29**

No expansion device is fitted at this time and one may be warranted.

Recommend commissioning and repairs as appropriate.

Recommend testing all hot water outlets and repairing if necessary once in operation.

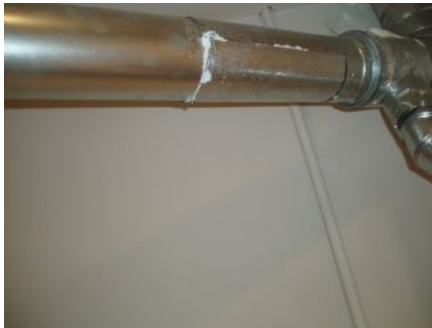
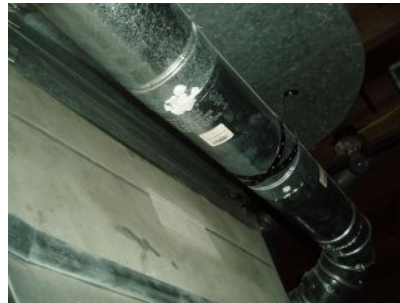
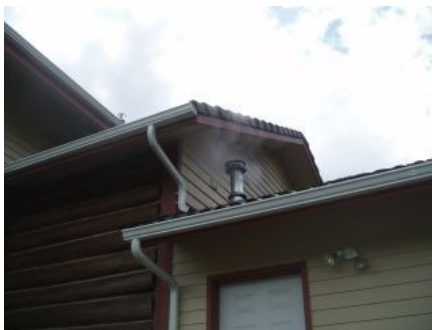
The furnace is producing calcium/salt deposits which are expelling through joints in the flue pipe. This is caused by improper venting and or temperature differentials causing condensation inside the flue.

The length of flue and exit location under an eaves needs to be evaluated and probably recited to ensure proper operation.

Recommend the same.

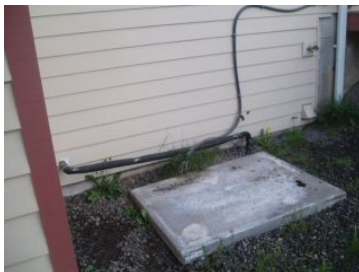
**Photo 30**

The cooling section of the HVAC system is not operational due to a missing condensing unit. As the home is weSt facing with large windows into the living space the solar gain will be great and some remedy is recommended with appropriate cooling installed and commissioned also.

Recommend the same.

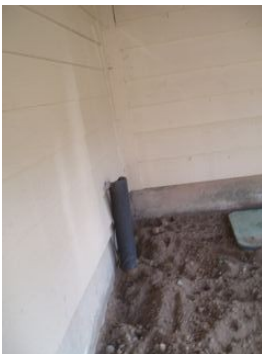
**Photo 42**

The new mains water pipe is not fully insulated and should be.

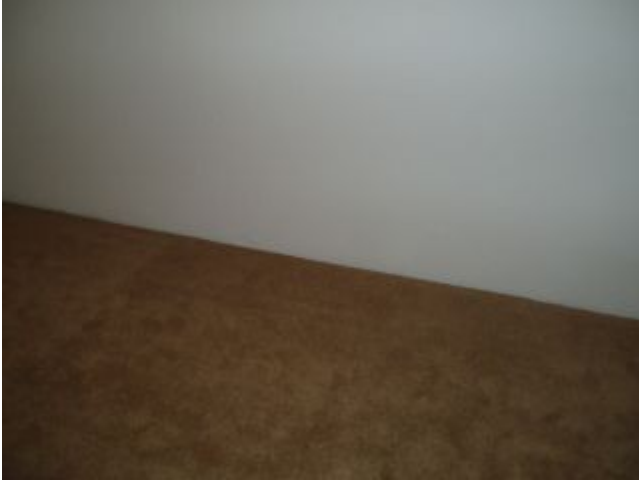
**Photo 35**

Past moisture wicking can not be seen due to the remodel.

The integrity of the slab can not be seen due to fresh carpeting.

Baseboard trim is missing through out. Recommend installation of the same.

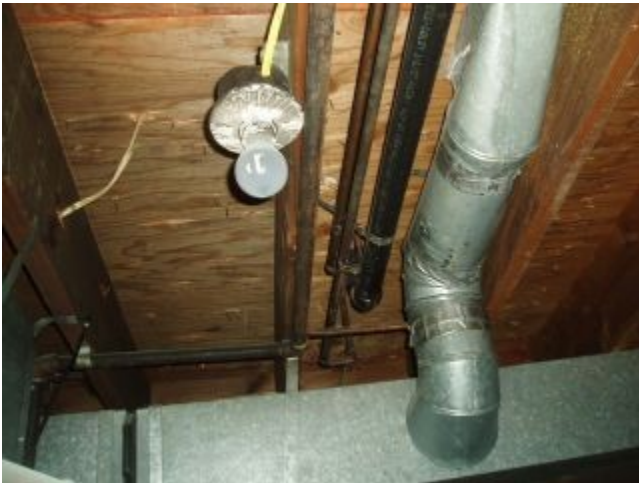
**Photo 28**

Old soot from the garage fire is still present in the furnace room and may want to be cleaned.

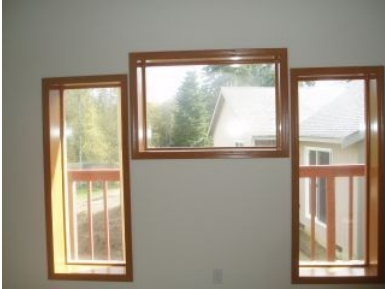
**Photo 37**

20) 🛠️ Master bedroom windows have some condensation between panes and may want replacing.

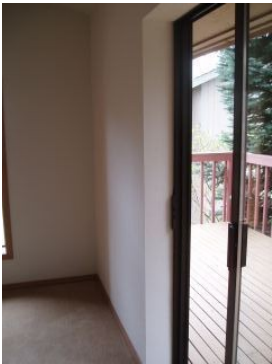
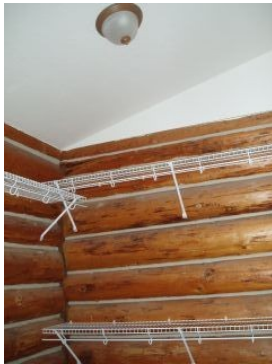
21) 🔍 The log walls generally have an R value of 1.4 per inch and therefore they fall short of current R-21 standards.

The interior walls have in general been covered in a drywall and it is not known if any additional insulation was added or not though the walls do seem to be void of any. Recommend seeking clarification from the builder.

The general insulation that can be seen seems insufficient as in the furnace room the floor has not been insulated and the walls have R13 batts though some are missing.

Recommend that the building remodel plans be provided and the inspection record also. It would seem that the builder and the "grandfather" rules are being relied upon i.e. The remodel is not to current insulation standards.

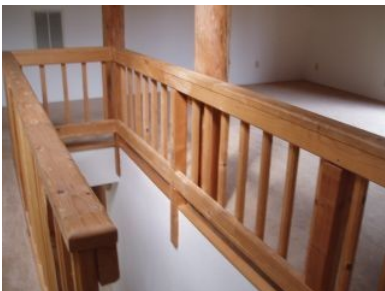
**Photo 18**

22) 🛠️ Some upper railings are a little loose and may want to be secured.

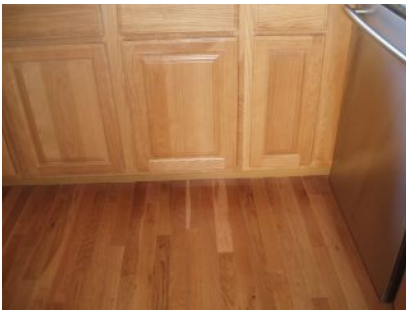
**Photo 47**

23) 🛠️ The kitchen floor and cabinets have not been trimmed out yet and should be.

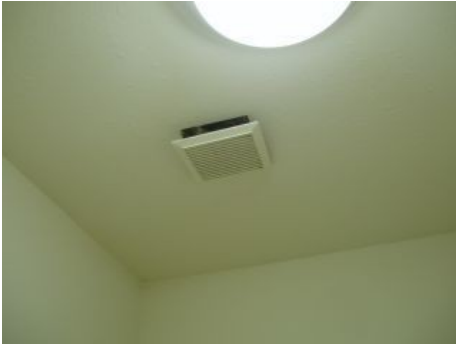
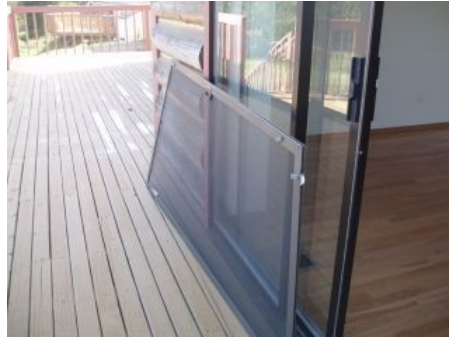
The rear screen door needs to be remounted appropriately.

A bathroom fan needs cleaning of dust/debris.
